Re: Notice of Violation  
Compliance Evaluation Inspection  
MID 048 989 891

ATTACHMENT A  
MPI Inspection Photographs  
MID 048 989 891

Attachment A  
Photographs for MPI RCRA CEI  
MID 048 989 891  
May 15, 2013

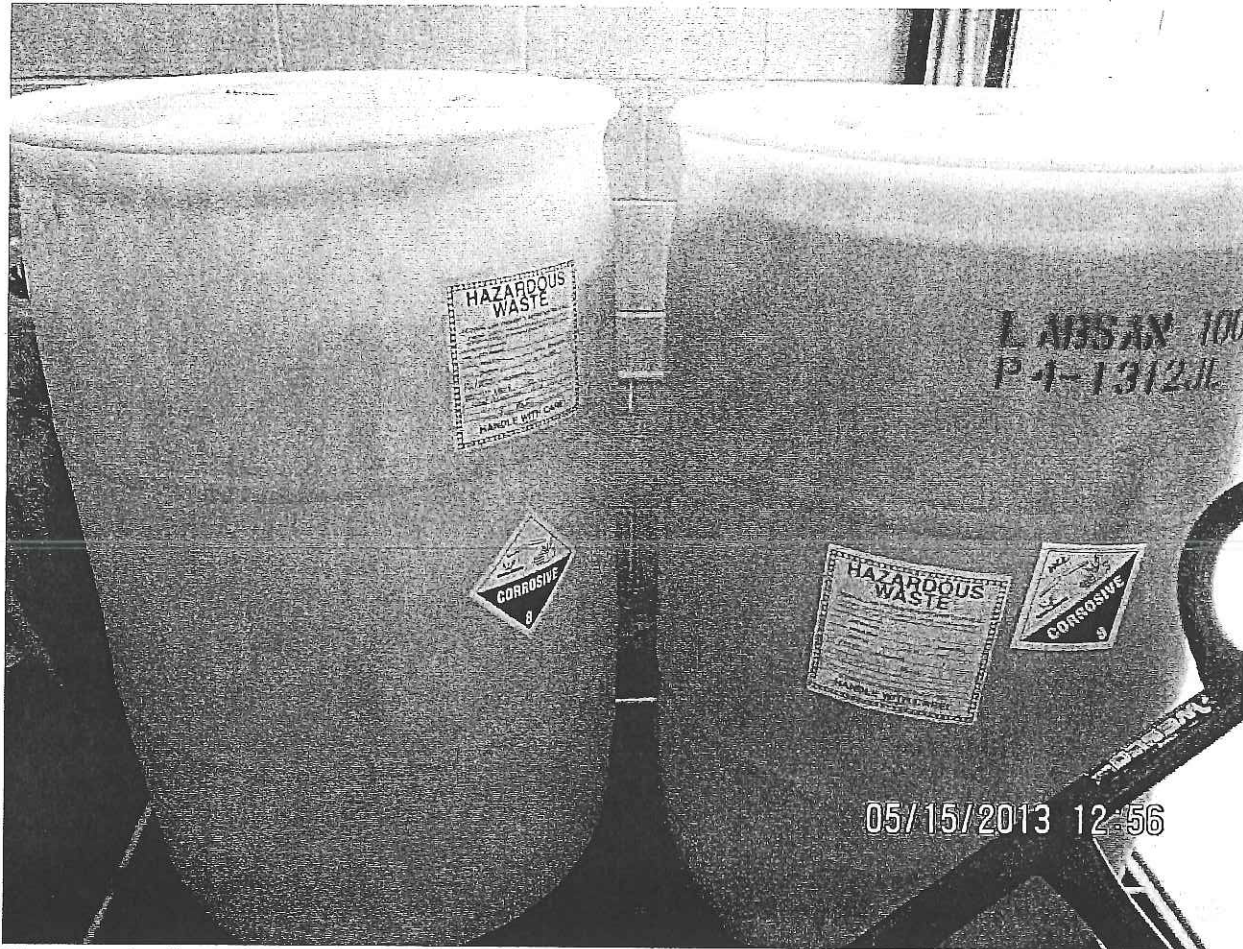
Photograph: #50

Photograph Location: 90 Day Accumulation Area of the Hazardous Waste Building

time of the inspection with accumulation start date of 5/15/2013. The DOT shipping information was listed as waste hydrochloric acid was also provided at the time of the inspection. See Photograph #50.

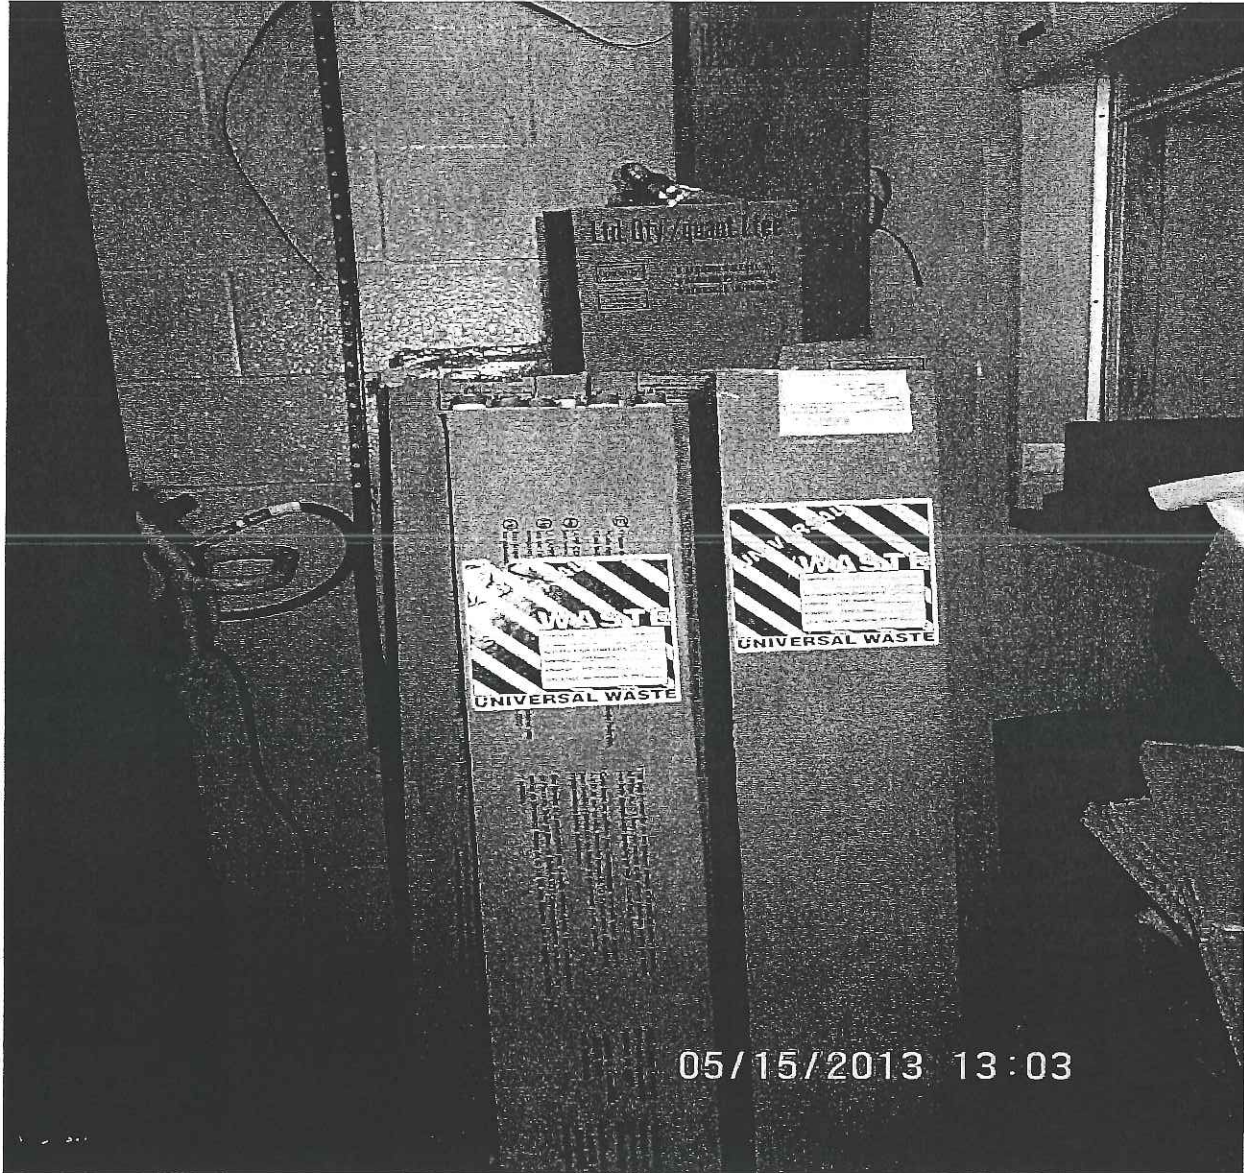
Photograph: #52  
Name of Photographer: Cindy Dabner  
Date/Time of Photograph: May 15, 2013  
Site Location: 54943 North Main Street, Mattawan, MI 49071  
Photograph Location: Hazardous Waste Building  
Description: Universal waste marked and labeled at time of inspection
